Austin Heritage Tree Foundation
ATT: Zoila Vega

RE: 504 E. 8th st. Austin Tx. 34" Escarpment Live Oak

Following is our health assessment based on the site visit performed on Monday October 5th 2015.

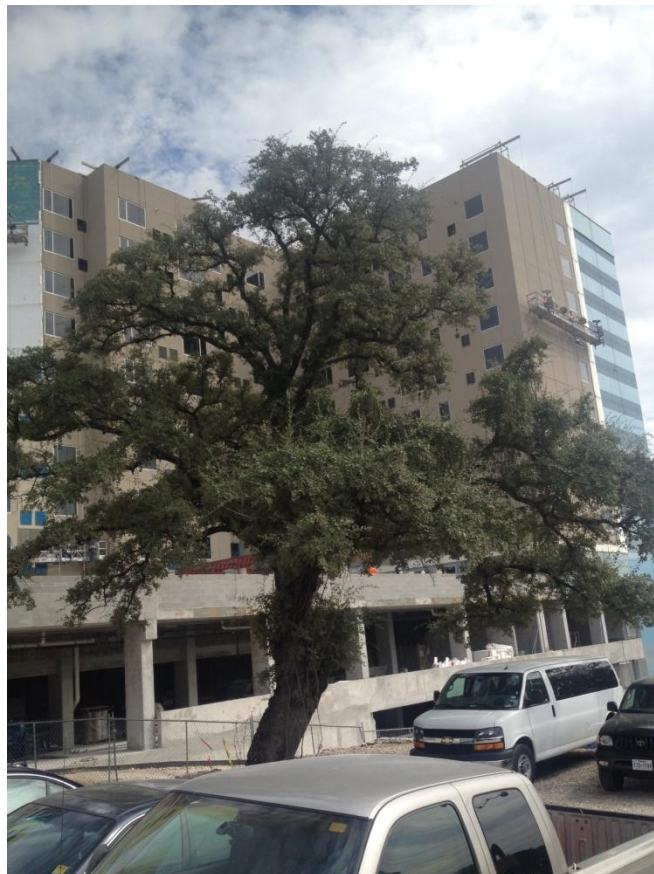
As the overview photo from the first page and the photo on the right shows, vigorous growth has occurred this year with one year twigs extending 12 inches and sometimes more, whether from the stem sprouts, the lower denser canopy branches, or the top canopy.

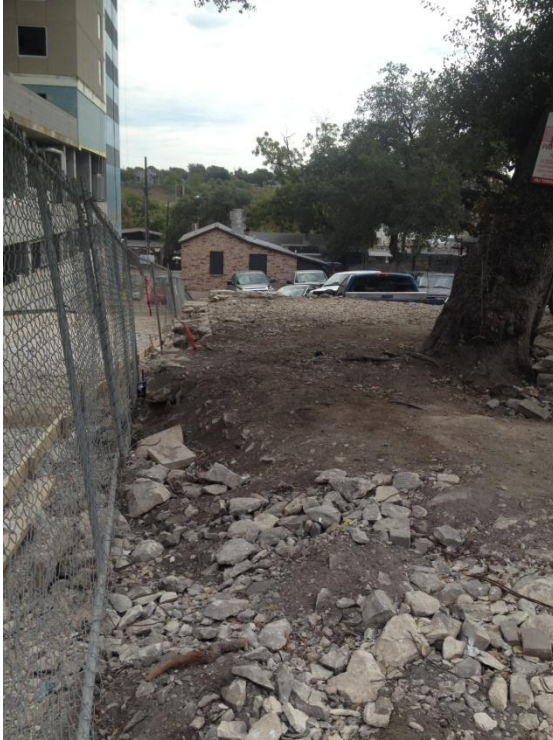
Root Zone:

The soil and ground treatment reveals a very poor growing environment, with asphalt, construction rubble and several recent minor scars on the buttress roots.

The north and east side of the root zone show a grade change held by an old retaining wall. Roots show some old scarring and rips. We did not see signs of recent significant damage on either side. Live shallow roots growing under the east retaining wall are visible. No roots were seen beyond the north side retaining wall but this side is currently under construction and new surface treatment is being installed. As the wall is several decades old, we can assume that the tree has **self corrected** and adapted from this old

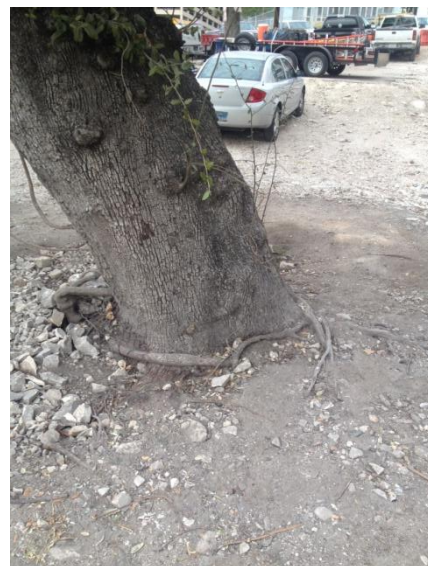
Several small to medium size (-3") choking roots are present. A photograph of the excavated root collar is available on the report from Austin Tree Specialist on file. Many smaller roots are seen below the current rubble. These roots are not yet embedded in the stem tissue and can be removed by careful pruning. Their removal is a standard prescription.

We cannot tell from that photograph if there are signs of significant rot or decay in the excavated area. No signs of rot were seen above the rubble. Traditionally, basal rot would show fruiting bodies on the outside of the stem. New fruiting bodies usually appear in the fall, at this time of the year. Stem sap rot would show fermented sap bleeding from the lower section of the stem right above the root flare. None of these were observed.

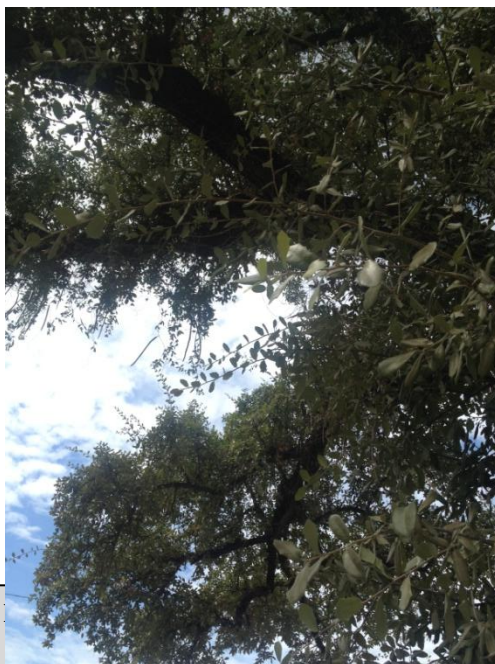
The canopy is fairly well balanced but at a poor to fair density of 60%. Most of the thicker canopy is on the bottom half of the canopy. Sky patches are clearly visible through it when looking up from the base. Foliage is present to the top of the limbs but increasingly thinner as you go up. The foliage density is good close to the stems. No signs of dieback. Sprouting of leaves is present through the length of all branches and mixed in with an aggressive vine.

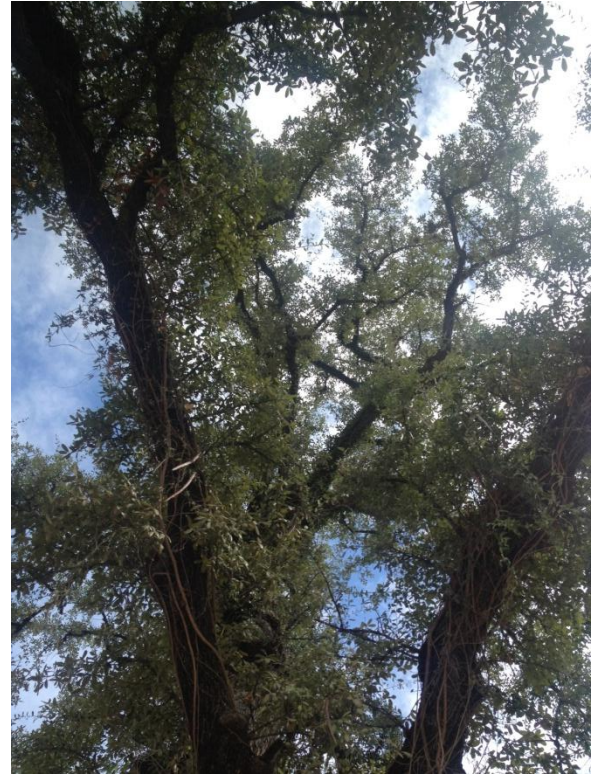
The foliage is affected by spider mites as well as covered by dust from the nearby construction site. The dust does reduce the effectiveness of the foliage.

The photo on right shows the canopy density when looking up from the base.

If this tree is to be preserved, we recommend a thorough multi-year preservation plan that will account for protection against insect and disease attacks as well as improve the site conditions. Improvements should include increasing pervious cover by removing asphalt trough as much of the CRZ as possible, incorporating organic matter in the top layer, occasional watering to supplement natural rainfall, and protecting the surface with a layer of mulch, ideally leafy mulch. The root flare should be restored as much as practical and protected by a tree well if the grade change warrants it. Additionally, a yearly fertilizer application can accelerate the recovery and will then need to be gradually phased out.
